Montgomery County Fire and Rescue Service

POST INCIDENT ANALYSIS

Third Alarm House Fire
7105 45th Street
Bethesda, Maryland

Incident Date: September 6, 2013

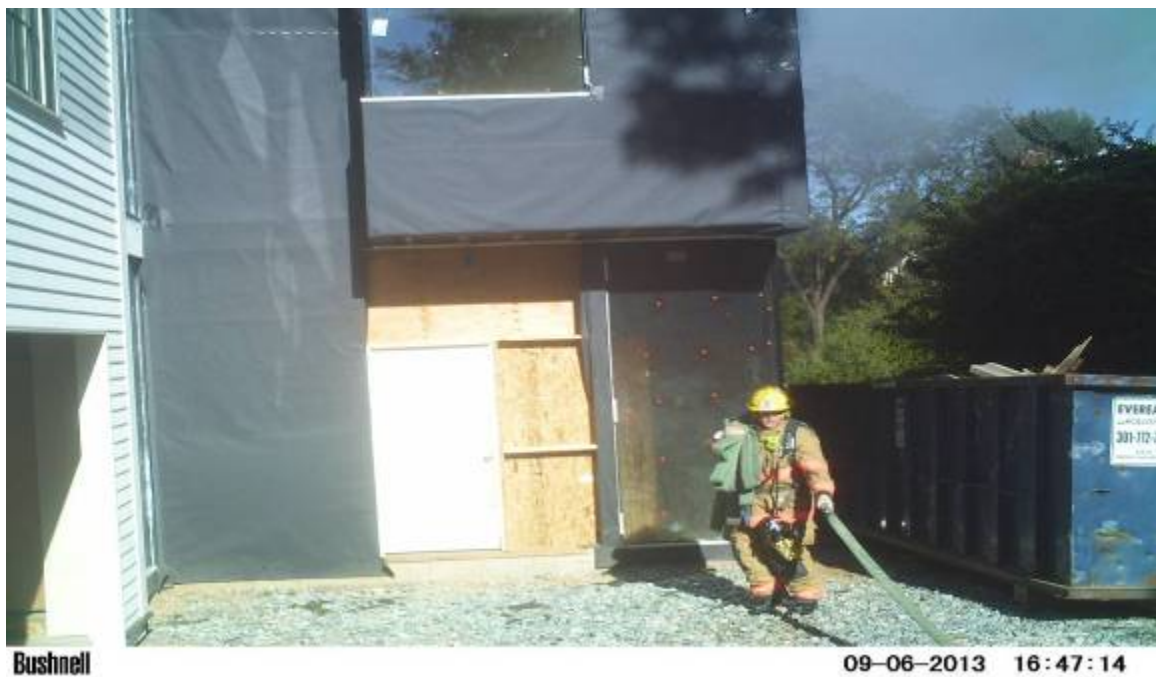
Fire Venting from the Delta side 3:40 from dispatch / 1:35 from initial line being stretched

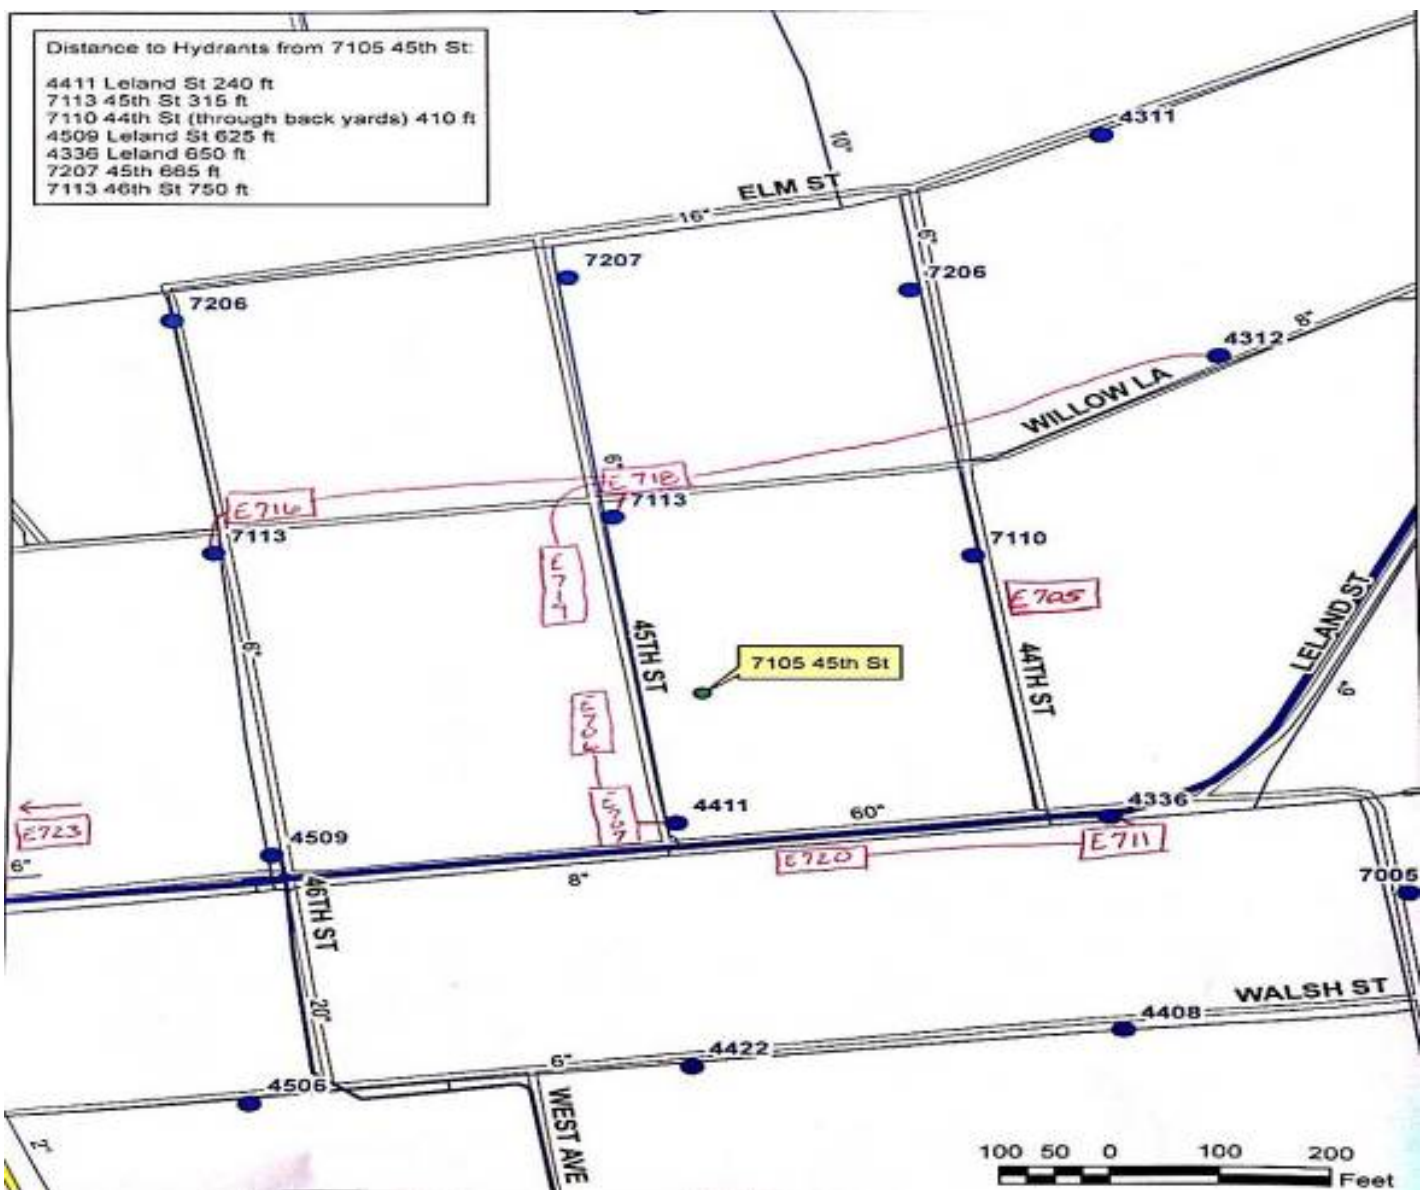
1. The primary hydrant at 4411 45TH Street had a maximum flow of 765 GPM when no other hydrants in the area were opened. The hydrant experienced 10-15 pounds per square inch (PSI) drops in residual pressure if the adjacent hydrants were also opened.
2. The secondary hydrant at 4336 Leland Street had a maximum flow of ~800 GPM
3. The third hydrant used was at 7110 44TH Street and had a flow of 1100 GPM.
4. The fourth hydrant used at 7113 Willow Lane was the primary water supply for interior operations in the Bravo exposure and had a maximum flow of 500 GPM with 0 PSI residual pressure.

Paramedic Engine 707 on the hydrant at 4411 45TH Street
supplying Paramedic Engine 706
